Site/Project Location: MP 125 to 125.5 Spread 7-8

Date of Inspection: 26 September 2016

Keitu Inspector: RJS

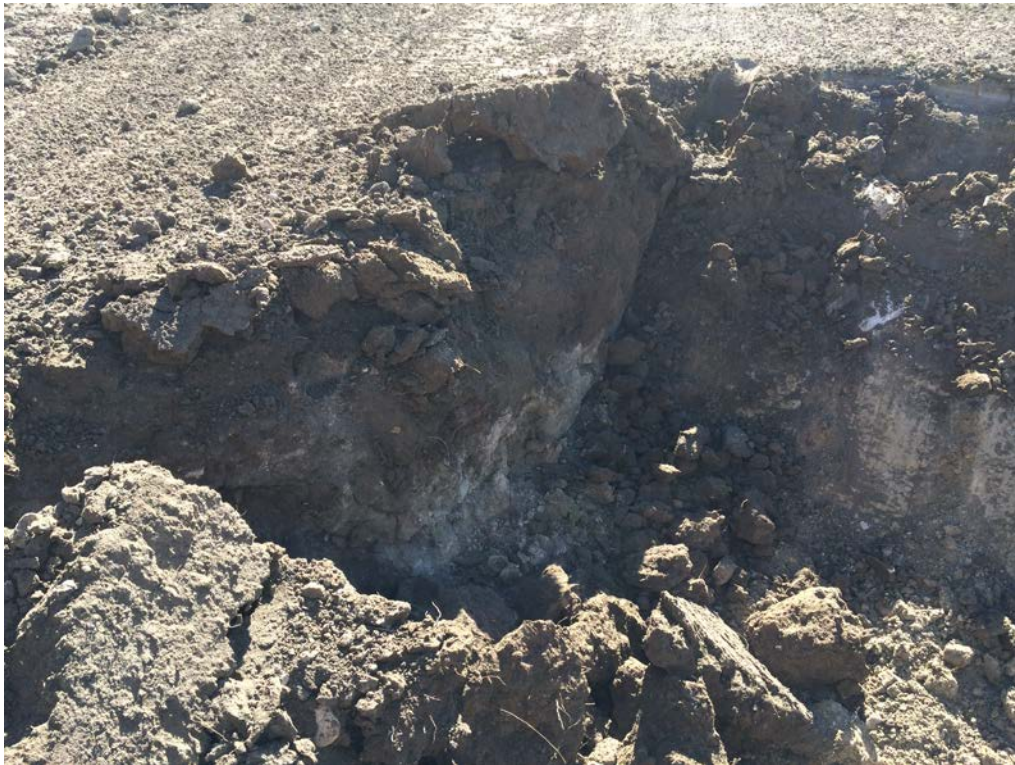
47.70548°N 101.29469°W

Report Photo #5 "Center of ROW - Visible Topsoil Layer":

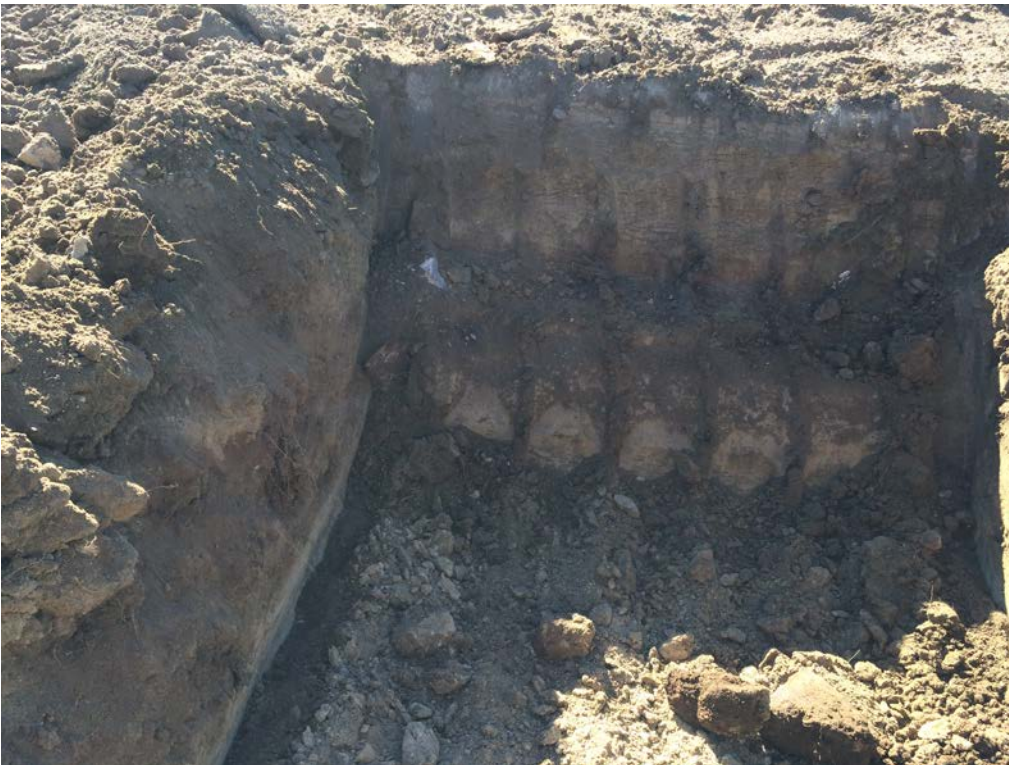
47.70548°N 101.29469°W

Report Photo #7 “Center of ROW – Visible Topsoil Layer”:

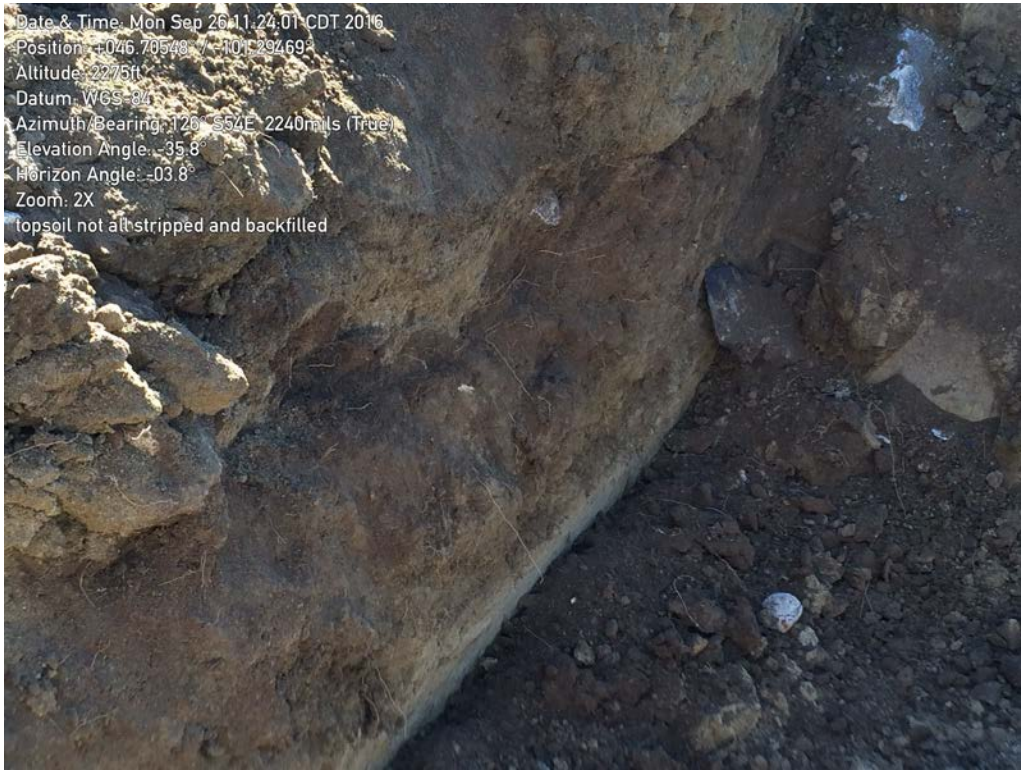
47.70548°N 101.29469°W

Report Photo #8 "Center of ROW - Visible Topsoil Layer":

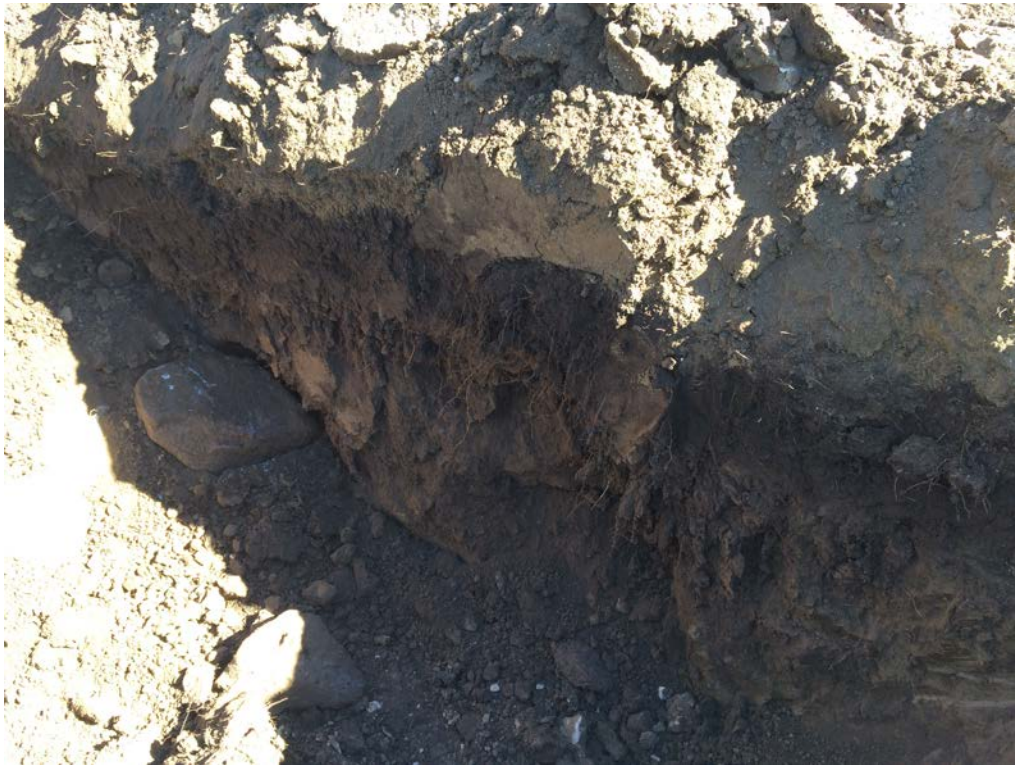
46.70547°N 101.29477°W

Report Photo #11 “Visible Topsoil Layer Topped w/Subsoil”:

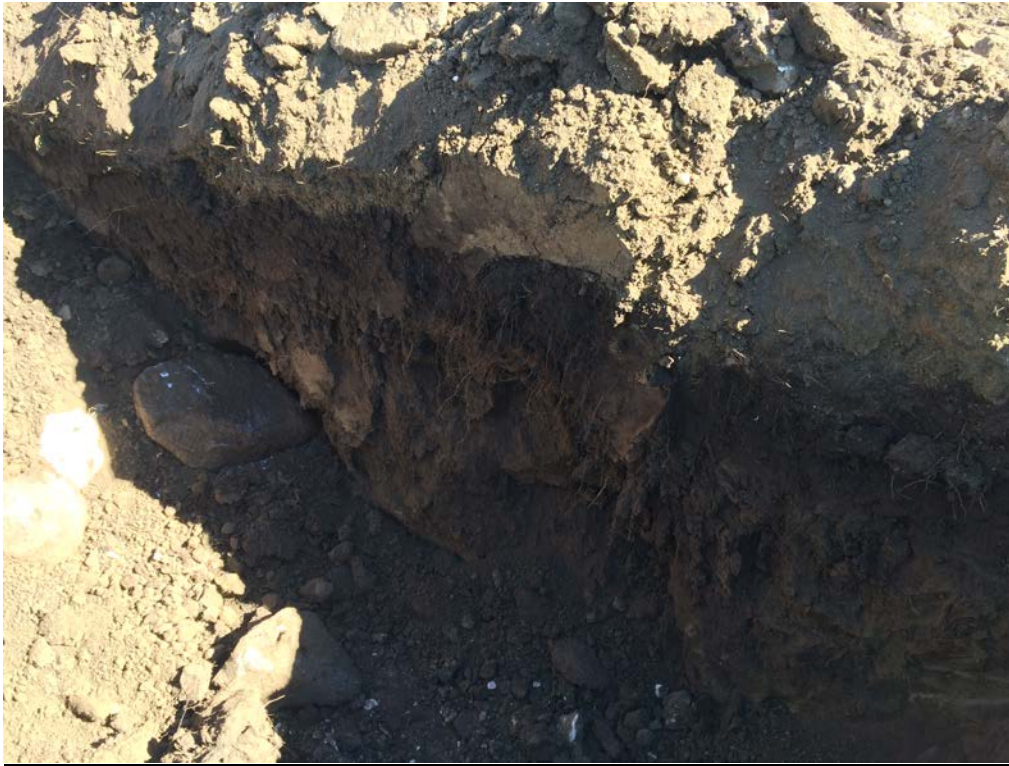
46.70547°N 101.29477°W

Report Photo #12 “Visible Topsoil Layer Topped w/Subsoil”:

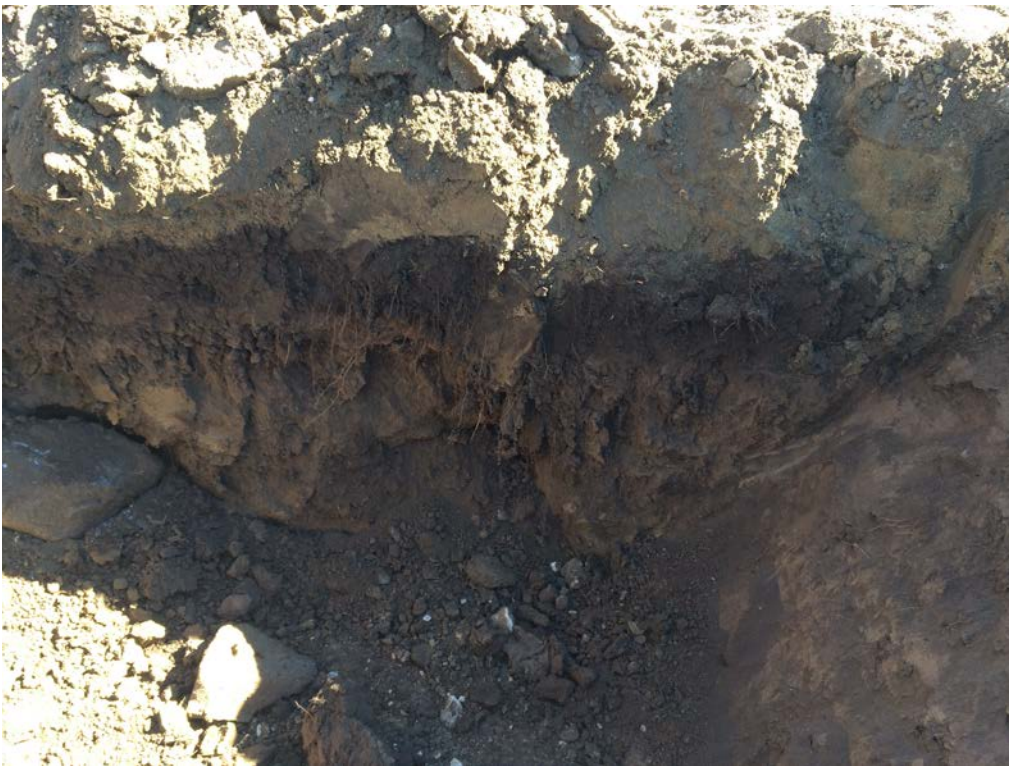
46.70547°N 101.29477°W

Report Photo #13 “Visible Topsoil Layer Topped w/Subsoil”:

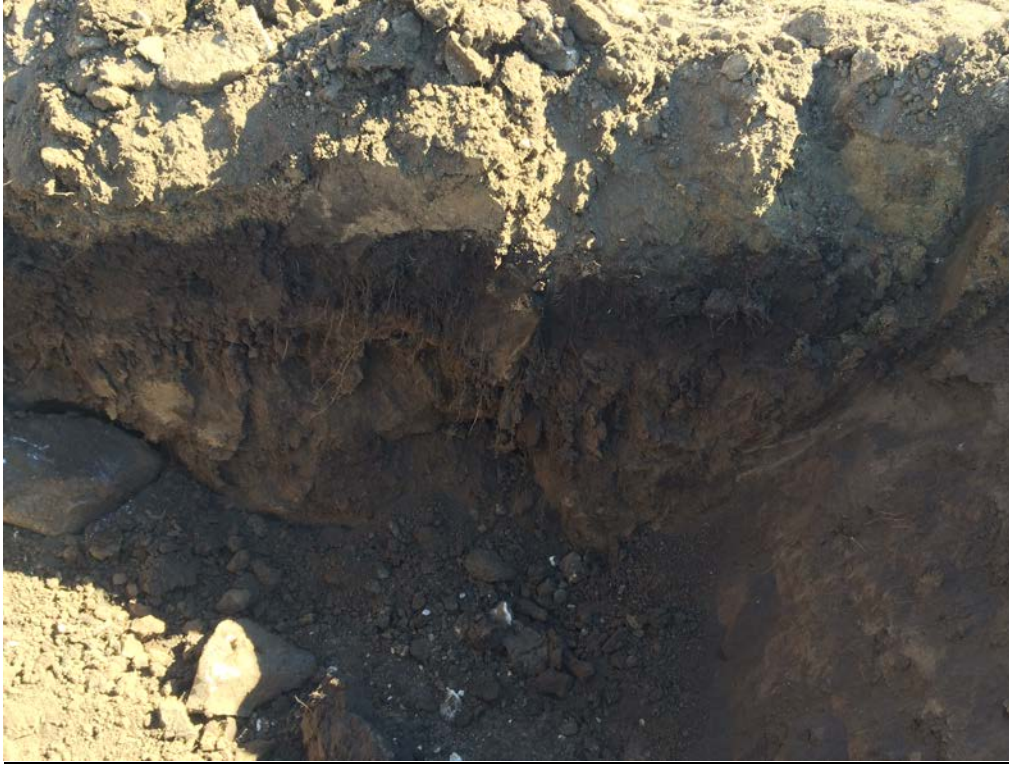
46.70547°N 101.29477°W

Report Photo #14 "Visible Topsoil Layer Topped w/Subsoil":
